# RECYCLING PP INJECTED WASTE

## **Shredding and Extrusion Walkthrough**

3devo's experience with the shredding and extrusion of Polypropylene (PP) injected waste.

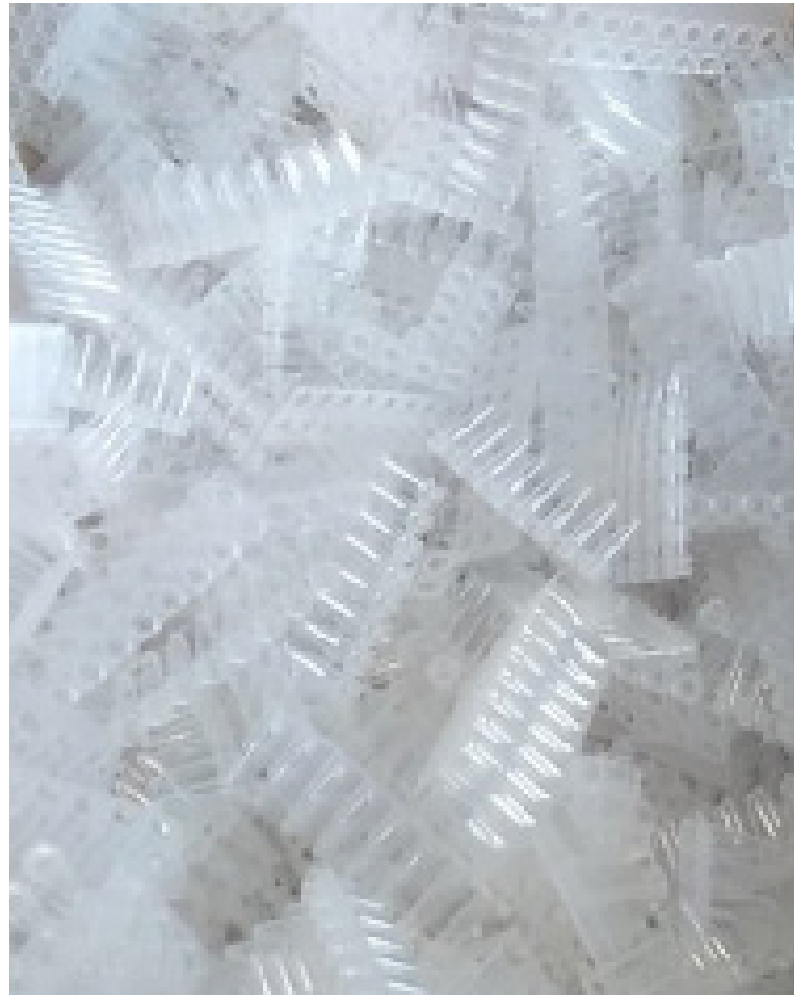
*Figure 1 - Batch of injected waste, some of which was already precut (as explained in Chapter 2)*

The goal of the test was to recycle deep well plates made of injected PP for genomics applications, into several spools of **1.75mm filament**. Figure 1 is a picture of the initial batch of injected parts (the colored parts and most of the large deep well plates were set aside because they were found to be quite complex to shred, as explained later).

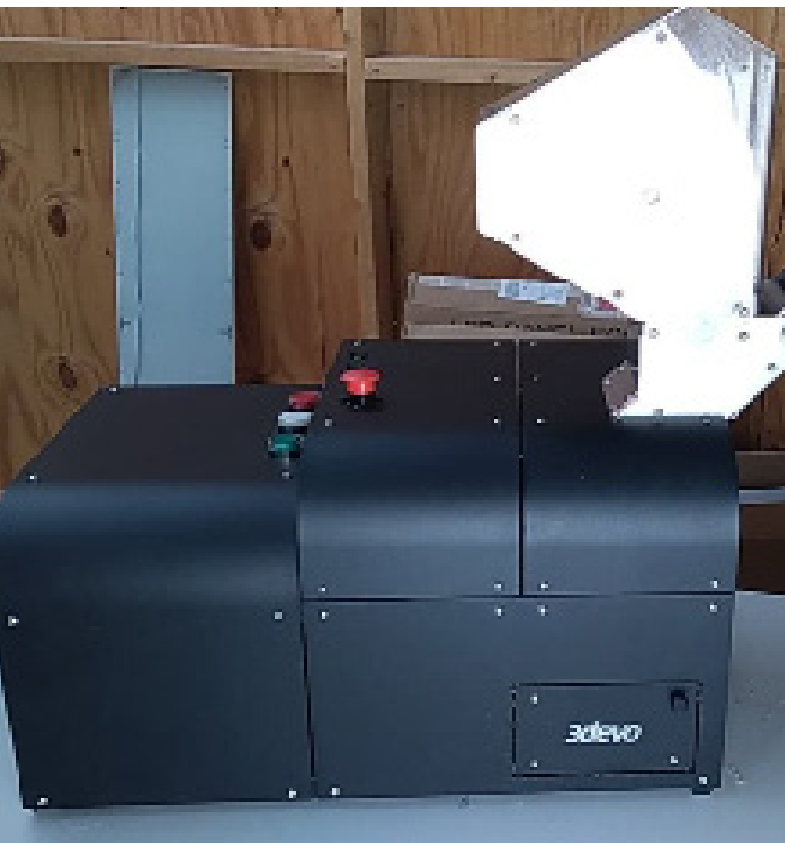
*Figure 2 - Picture of the SHR3D IT - Shredder*

The shredding step was performed on the SHR3D IT (shown in Figure 2) equipped with a 4mm particle filter. The initial injected parts being too wide in size to be properly fed in the shredder. Feeding the initial parts was found to be possible but time-consuming and troublesome. The solution to speed up the shredding process was to manually cut the bigger parts into smaller pieces using conventional office scissors, this operation took approximately 15min.

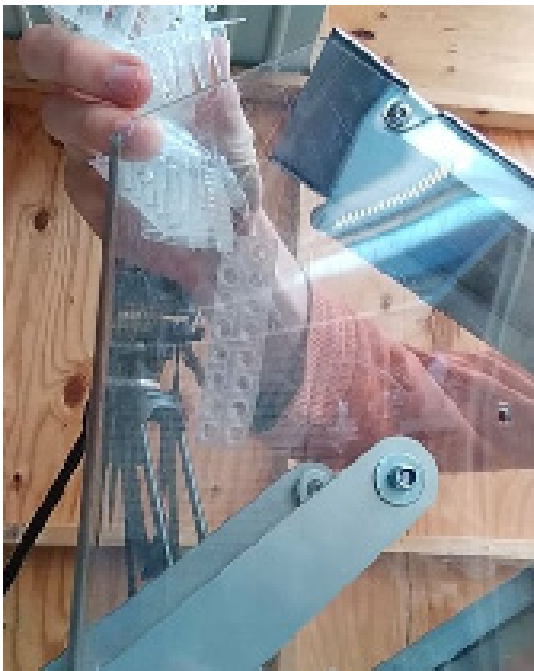
**Figure 3 - Feeding the SHR3D IT**

Using this method, the feeding of the shredder was then very easy, and the shredding process quickly gave good results. Figure 3 is a picture of the feeding step, which shows that pre-cutting the parts into smaller pieces results in the good filling of the hopper.

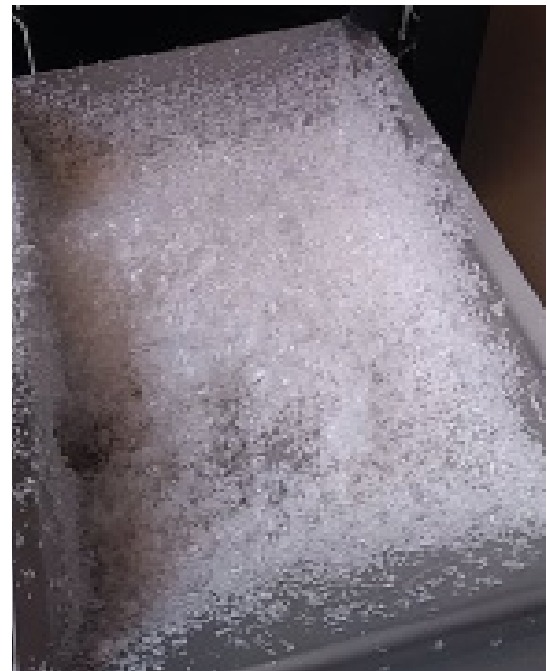
**Figure 4 - First sample of regrind coming out of the SHR3D IT**

Figure 4 is a picture of the first sample of regrind that was obtained after a few moments of shredding. It is known by experience that shredding a regrind again into even smaller bits can improve the feeding step during extrusion. In addition to being beneficial for the stability of extrusion, re-shredding a regrind can be done extremely quickly because the regrind flows much better than the initial parts into the throat of the shredder. Figure 5 shows that re-filling the hopper with the first regrind can be done easily, Figure 6 is a picture of the partially fed hopper. This second shredding step only took a few minutes.

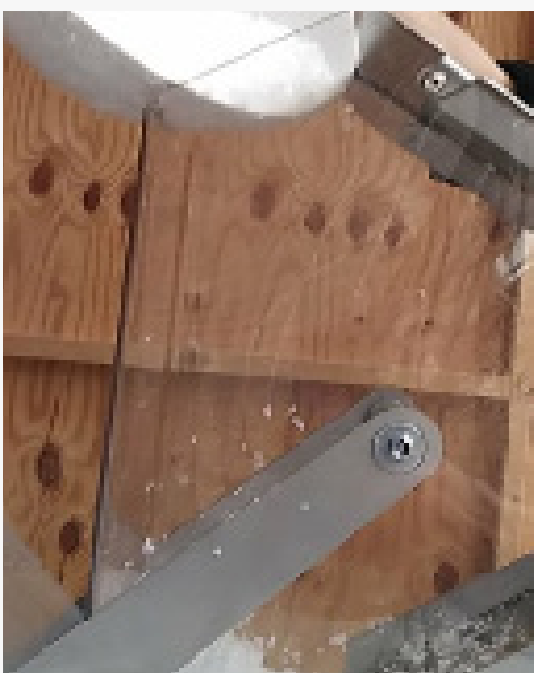
**Figure 5 - Easy feeding of the regrind for a second shredding step**

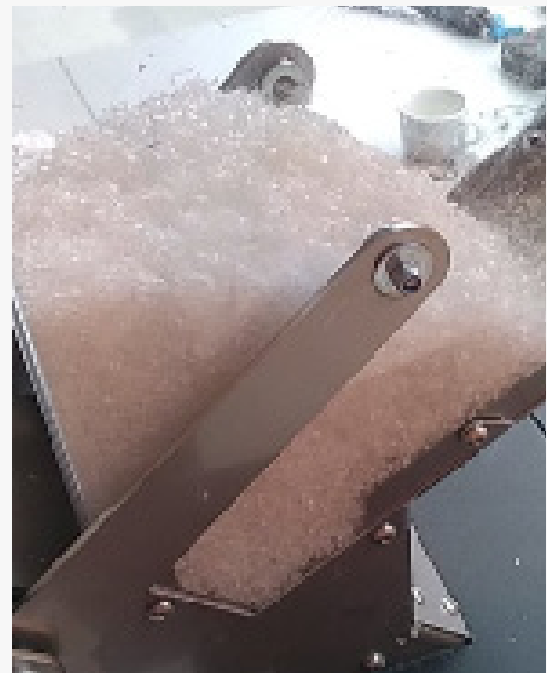
**Figure 6 - Hopper partially full of regrind**

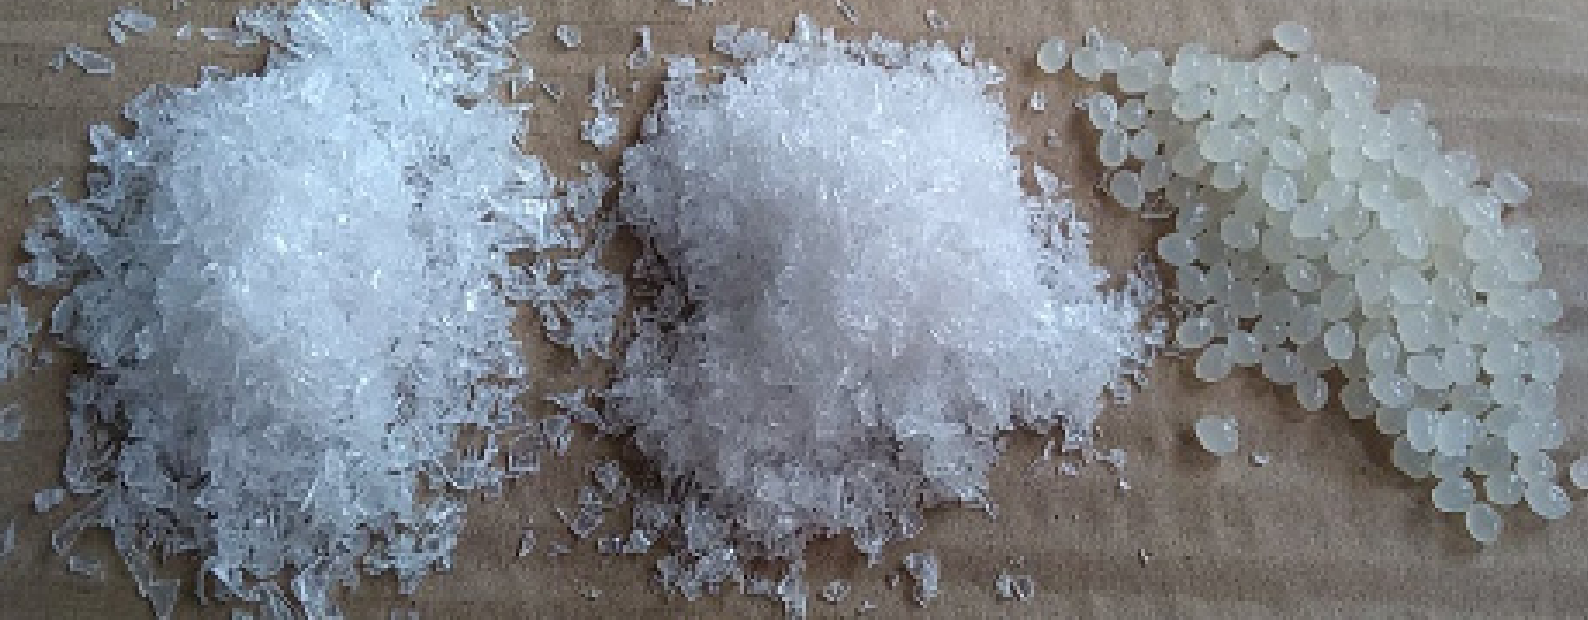
**Figure 7 -** Size and shape comparison between regrind (left), second regrind (center), standard PLA pellets (right)

Figure 7 is a picture meant to compare the shape and size of the first regrind, the second regrind (after a second shredding step), and standard Poly-lactic Acid (PLA) pellets commonly used in extrusion for good quality results. It can be seen that the particle size distribution is narrower in the second regrind, and that the particle size is inferior to standard PLA pellets, which is a first indication that the plastic will melt easily.

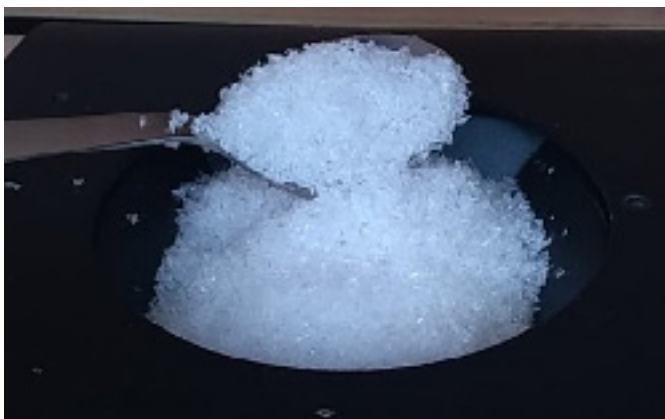
**Figure 8 -** Feeding the second regrind into the hopper of the extruder

Figure 8 is a picture of the feeding, Figure 9 illustrates the transition from PLA to PP. The transition results in a rather white and opaque extrudate, which then becomes more transparent and colorless.

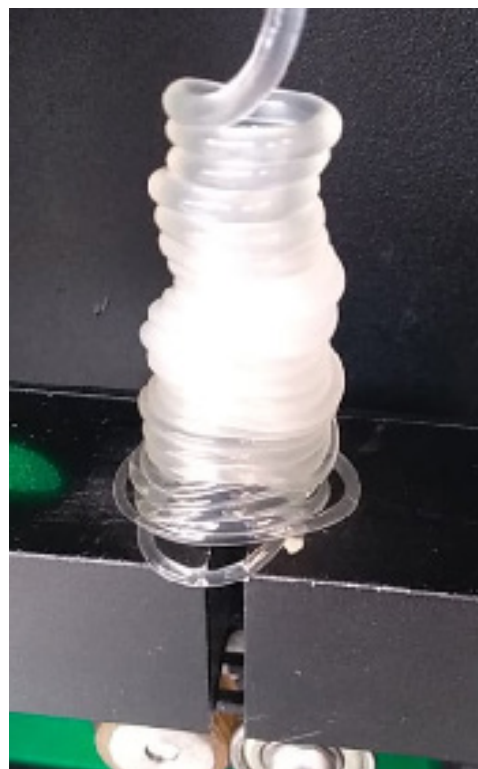
**Figure 9 -** Transition between purging PLA (transparent extrudate at the bottom) and PP (semi white and opaque extrudate above PLA)

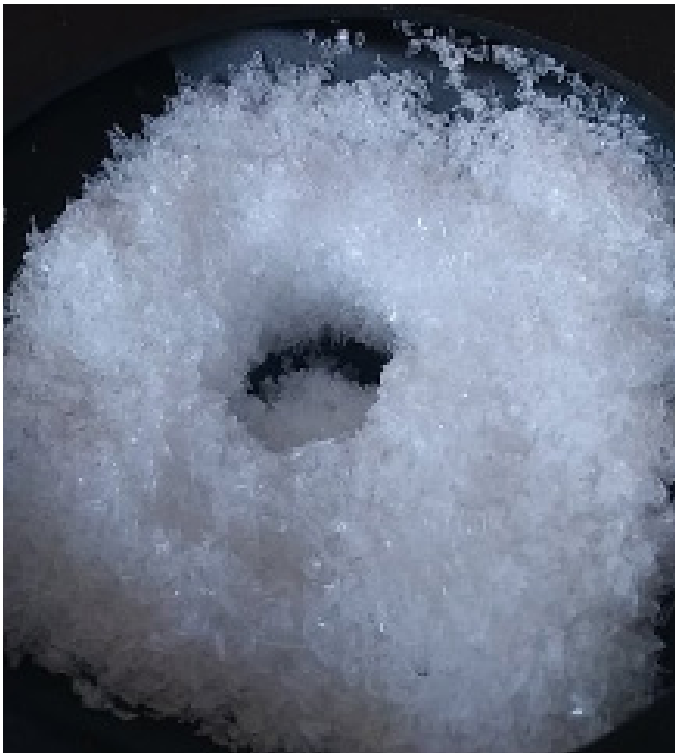
**Figure 10** - Rat holing occurring in the hopper

The resulting flow seemed to be sufficient and quite consistent, but a phenomenon called rat holing was noticed in the hopper, and the very fast crystallization of the material was found to be a minor issue.

**RAT-HOLING?** As shown in Figure 10, rat holing (or tunneling) describes a situation where the material does not flow homogeneously into the throat of the extruder. This is due to the jagged shape of the regrind and to its tendency to adhere electrostatically. This phenomenon can be fixed temporarily and with great care by stirring in the hopper using a stick.

**WARNING:** no fix has been found to prevent rat holing permanently, which means that it occurs repeatedly every few minutes. This issue is extremely common when dealing with any kind of regrind, and may lead to flow inconsistencies if left unchecked.

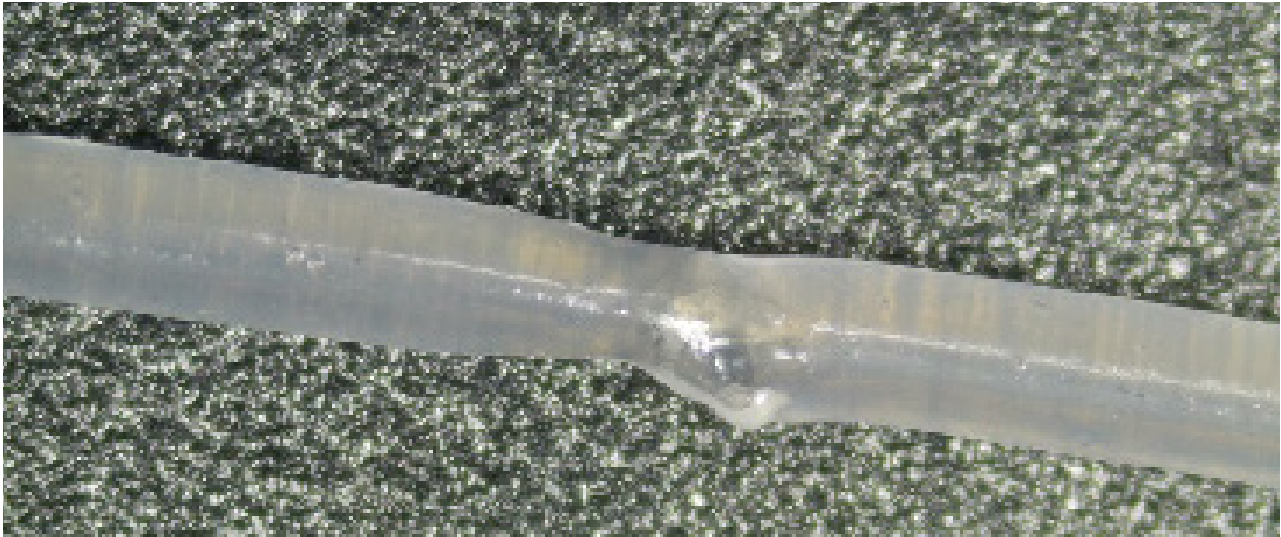
*Figure 14 - Microscope shot: view of the filament when temperatures were set too low*

At these temperatures, it seemed like the filament did not contain any bubbles, but a few unmelted particles, as shown in Figure 14. The nature of these minor solid plugs was not clear: they could consist of:

- PP unmelted particles, in that case the obvious solution was to increase the temperatures
- Impurities (such as PP of a different grade, or foreign bits of plastic which contaminated the formulation during the storage), in that case the solution of increasing the temperatures could also work, with less certainty

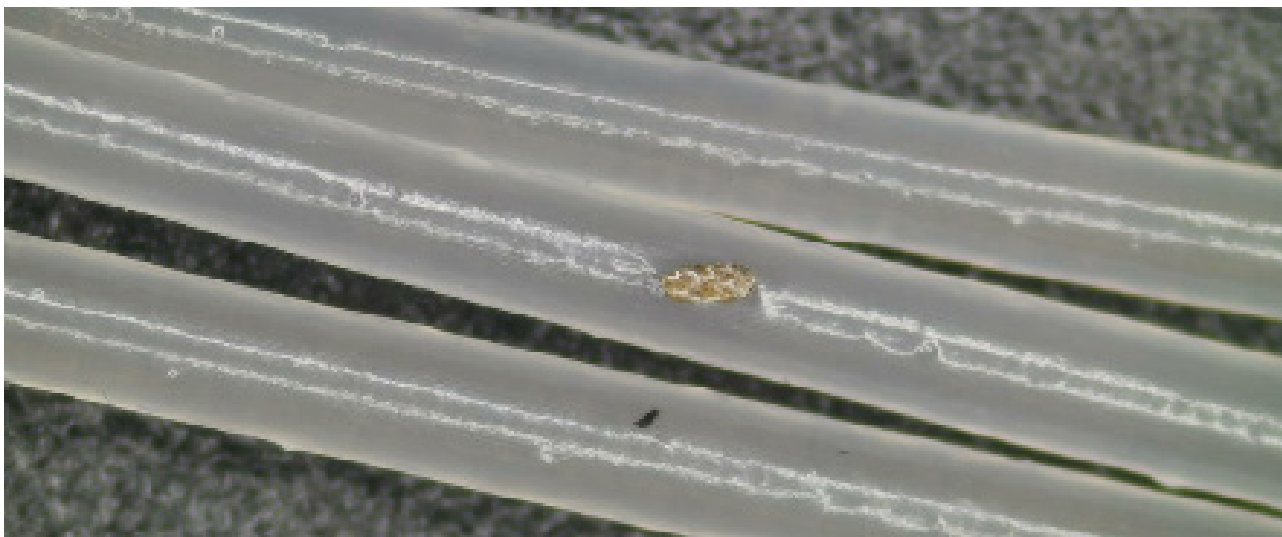
*Figure 15 - Microscope shot: view of the filament of good quality, only the dust remains*

These settings seemed to be optimal: the filament thickness was quite consistent, its cross-section was rather round, it did not contain bubbles. However, it contained fine dust, as shown in Figure 15, but this issue could not be solved. Regarding the dust, more will be said in Chapter 7.

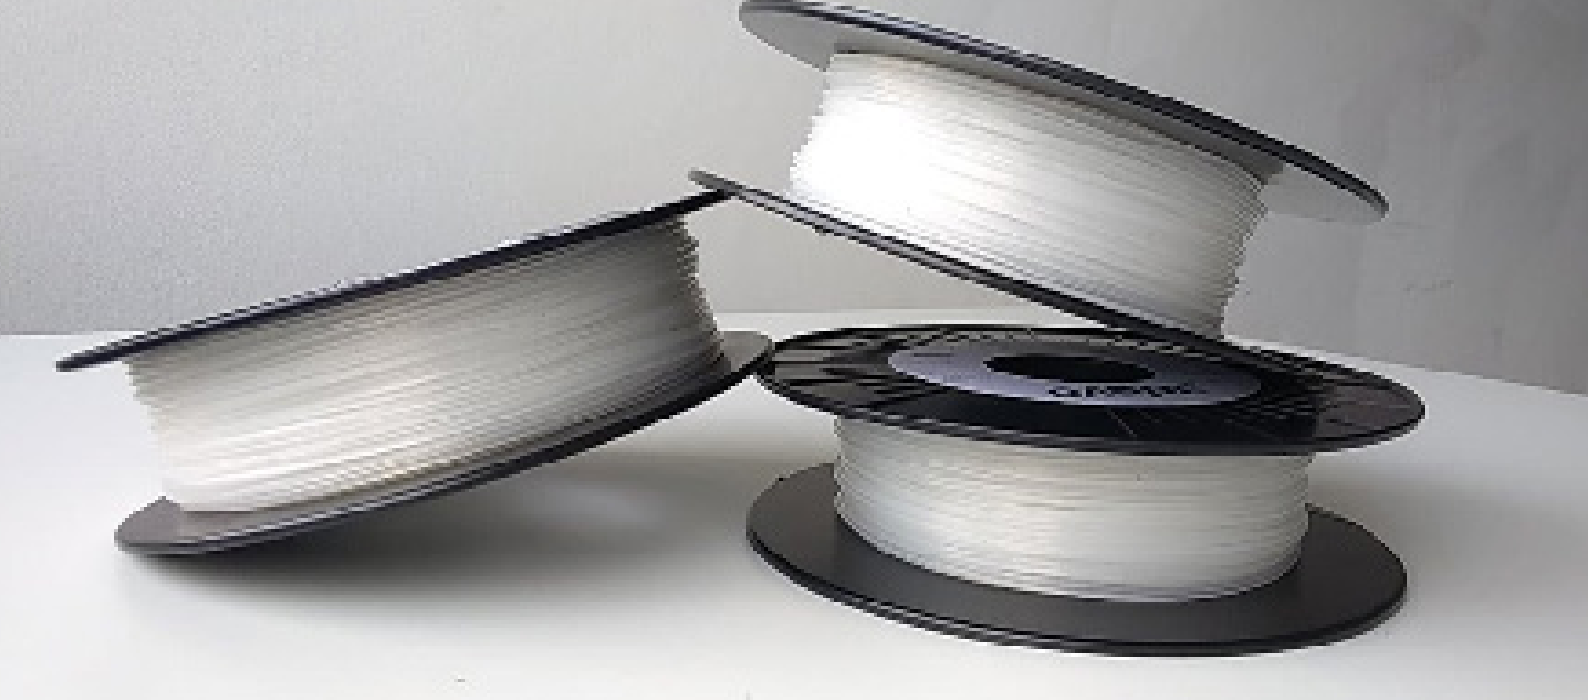
Figure 18 - Final spools of recycled PP

This extrusion experiment was extremely promising. Indeed, 1.75mm filament of great quality and was obtained using a Precision equipped with a 2mm nozzle and a circular cooling device. Even though the actual 3D printability of these filaments remains to be tested, it can be said that the material can be processed very easily, without facing any major issue. It was found that shredding the material twice was a rather easy task which gave good results. The fact that the material could be processed at relatively low temperatures made the launching of the process and the purging steps fast operations. Figure 18 is a picture of the three spools which were obtained at 3devo out of the first batch of injected waste.
